THE ACOUSTICS OF ACCORHOTELS ARENA AND OTHER LARGE SCALE INDOOR POP VENUES

Christophe Rougier¹ Stephane Mercier² Martijn Vercammen³

¹ PEUTZ & Associés, 10 B rue des messageries, 75010 Paris, France

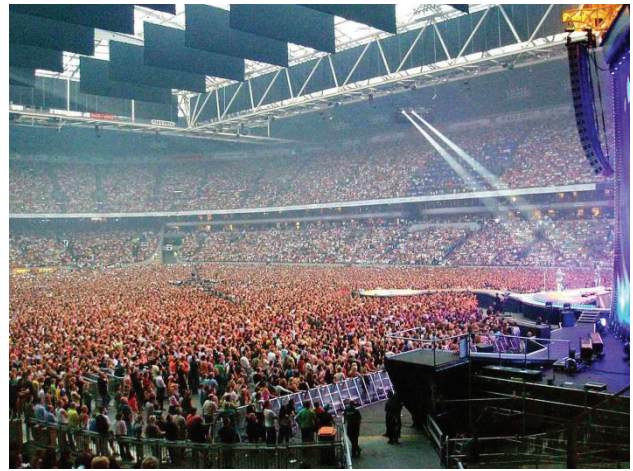
Figure 9. Johann Cruijff Arena, Amsterdam in concert

A special acoustic baffle construction was developed to reduce reverberation, especially in the low frequencies. The construction had to be very light, the middle parts only consist of 2 fabric layers with an air gap in between. This 3000 m² baffle construction is only present during shows and can be removed in a relatively simple way to allow maximum daylight for the benefit of the grass soccer field. The RT was reduced to 6,5 s (empty) and from 5.9 to 4.3 s. with full audience. A significant improvement, but still not easy to amplify this hall.

The Johan Cruijff Arena in Amsterdam, built in 1996, is basically a football stadium with a partly transparent roof, that can be opened and closed. Though not intended for concerts, the ability to close the roof makes the venue very suitable for large performances and shows. The volume is about $1.25 \cdot 10^6$ m³ and the audience capacity 70.000 for soccer and about 50.000 for concerts. Although in the original design a considerable amount of sound absorbing material was applied, the reverberation time was considerable: 10 s, in the empty stadium.

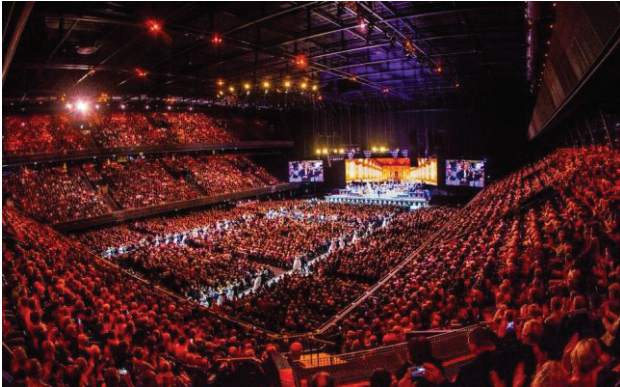
Figure 11. Ziggo Dome, Amsterdam

Like HMH, Ziggo Dome Amsterdam was built for a single purpose: a venue for popmusic of the highest acoustical quality. The Ziggo dome has a rectangular ground plan with two levels of tribunes. It has a volume of about 145.000 m³ and can accommodate an audience of 17.000 people. All walls and ceiling are covered with broadband absorption of about 30 cm in thickness. The tribunes have been made absorptive by openings in between the seating platforms (T-beams), see Fig. 12 left. The gallery (VIP area) between 1st and 2nd tier is weakly coupled to the main volume and is more lively. There are no disturbing echos and the RT is close to Eq. (1).

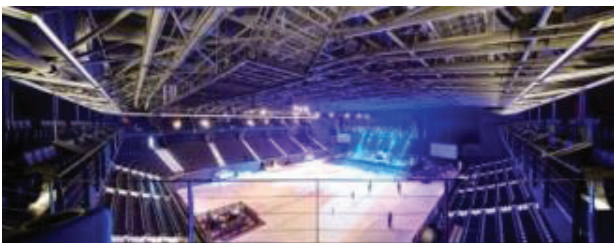
Figure 13. Volkswagen arena, Istanbul

The Volkswagen arena is built in the new financial district in Istanbul. The volume is 56.000 m³ and the capacity 5.800 audience. Based on Eq. (1), the aim is RT = 1,45 s. Walls and ceiling are covered with broadband absorption (mineral wool/foil/mineral wool) with different compositions, covered with a woodwool cement
